Manhole Inspection Summary

Manhole # S21E__020MH

Insp Date: **10/16/07 11:06 AM**

Location Address: **301 MONROE ST**

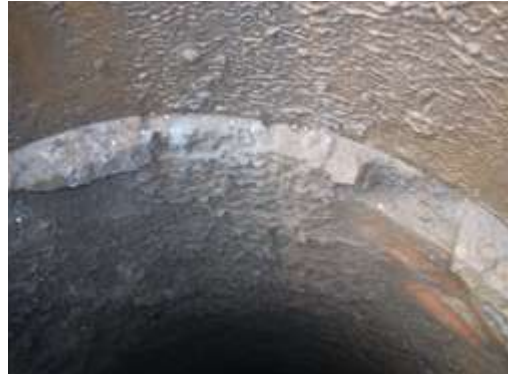
Defect 4

Count: **5** Missing: **0** ☒ **Corroded**

CORRODED STEPS

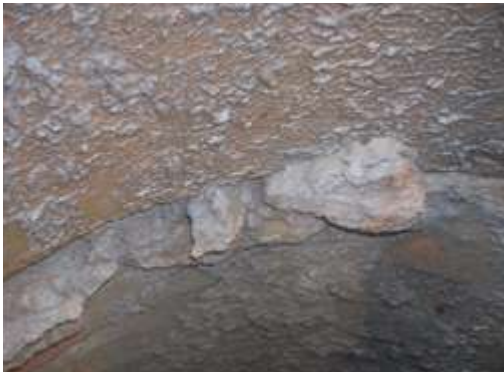
Defect 3

Infiltration: ☐ None ☒ **Joint** ☐ Cracks ☐ Mortar ☐ Roots ☐ Wall

INFILTRATION OF THE JOINT

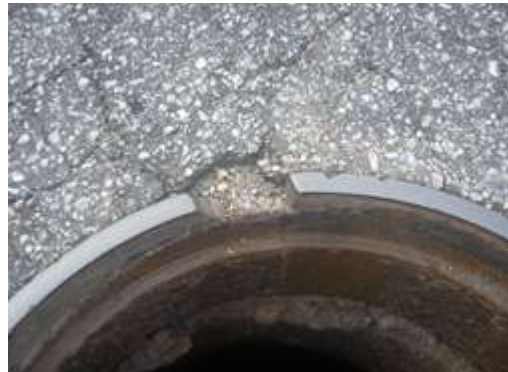
Defect 2

Condition: ☐ Sound ☐ Cracked ☐ Root Intrusion ☐ Loose Brick ☒ **Deteriorated**

DETERIORATED CHIMNEY

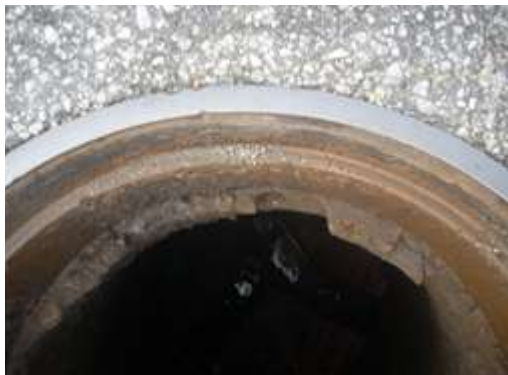
Defect 1

Offset: **1** (in.)

Condition: ☐ Sound ☒ **Cracked** ☐ Leaks

BROKEN FRAME

FRAME OFFSET

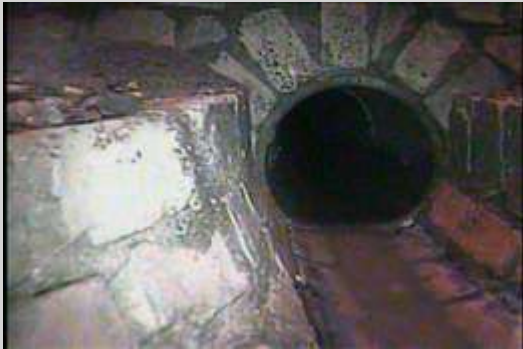
12 O'Clock Outflow

8 in. Circular Gravity Sewer
Pipe Out @ 12 O'Clock

Pipe Height: **7.2** (in.) Rod and Bar (Angled)
Pipe Material: **Clay** ☐ Pipe Lined
Invert Depth: **9.11** (ft.) Flow Characteristics: **Slow**
Deposits: ☒ None ☐ Mud ☐ Sludge ☐ Debris ☐ Grease
Silt Depth: (in.) Deposits Extent:
Infiltration: **None** Pipe Seal Cond: **Sound**

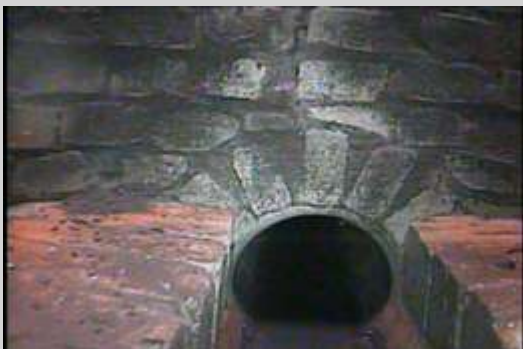
4 O'Clock Inflow

8 in. Circular Gravity Sewer
Pipe In @ 4 O'Clock

Pipe Height: **7.2** (in.) Rod and Bar (Angled)
Pipe Material: **Clay** ☐ Pipe Lined
Invert Depth: **9.06** (ft.) Flow Characteristics: **Slow**
Deposits: ☒ None ☐ Mud ☐ Sludge ☐ Debris ☐ Grease
Silt Depth: (in.) Deposits Extent:
Infiltration: **None** Pipe Seal Cond: **Sound**

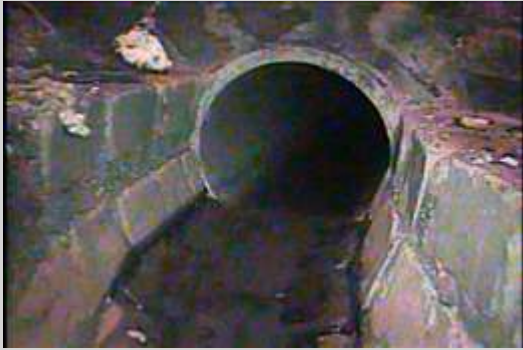
8 O'Clock Inflow

8 in. Circular Gravity Sewer
Pipe In @ 8 O'Clock

Pipe Height: **8.4** (in.) Rod and Bar (Angled)
